CASE STUDY:

AGGREGATE TAILINGS

Eliminating tailings with advanced separation

Eliminating Tailings Ponds at an Aggregate Plant

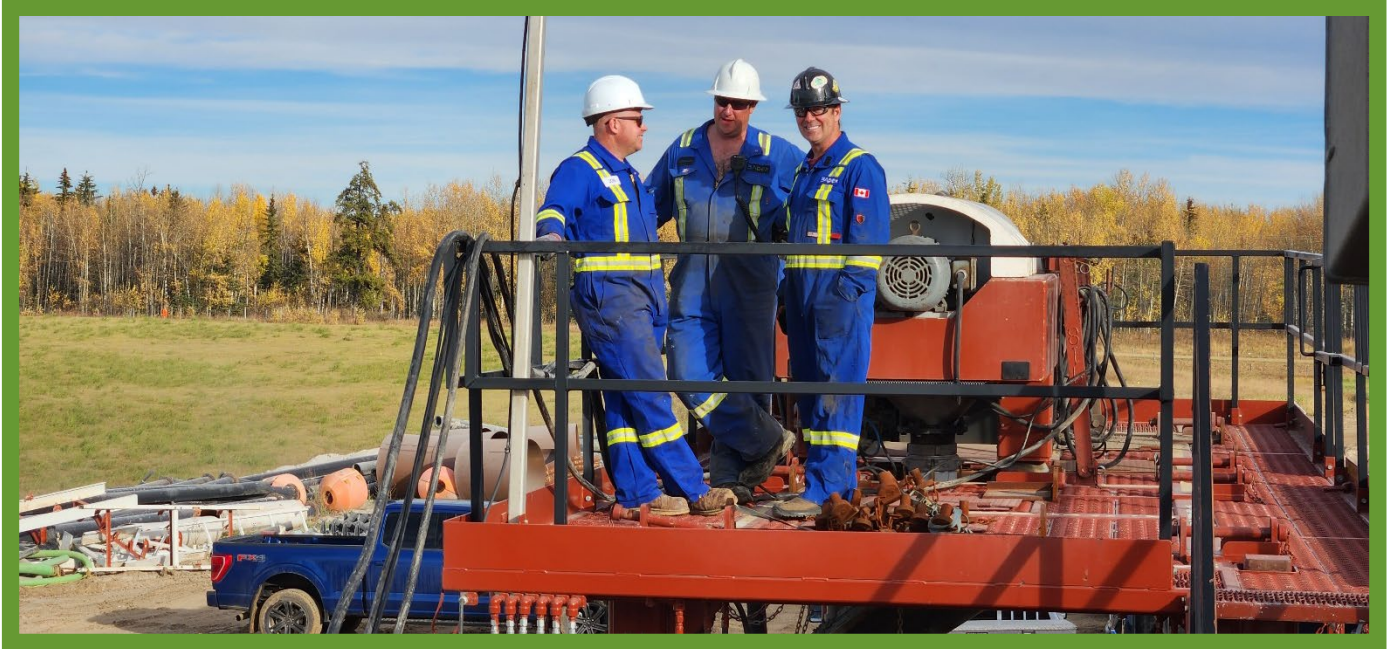
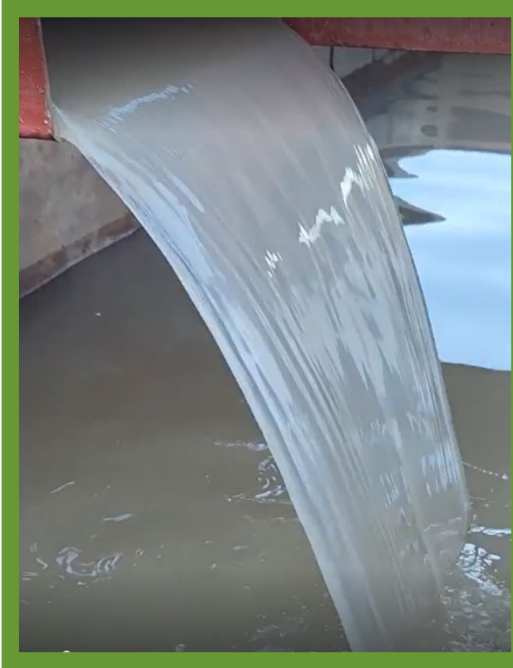
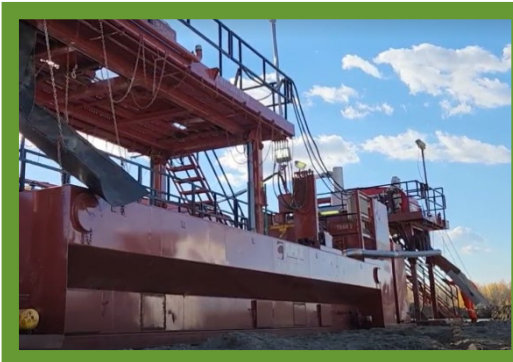
The set-up consisted of a Lynx 40 centrifuge mounted on a hydraulic stand above a specialized all-in-one clarifier tank that included mix tanks, a polymer feed system, pumps, sludge guns and suction controls. Apex also supplied a generator so get the system up and running as line power was not available.

The Apex equipment provided a fully closed-loop system eliminating all fluid discharge to the environment. All water was recycled back to the wash plant for reuse, and the removed solids were dry, stackable, and able to be stored on site as solid fill.
